MICRO-XRF

Analysis of a Roman sword with the M4 TORNADO

Application Note # XRF 443

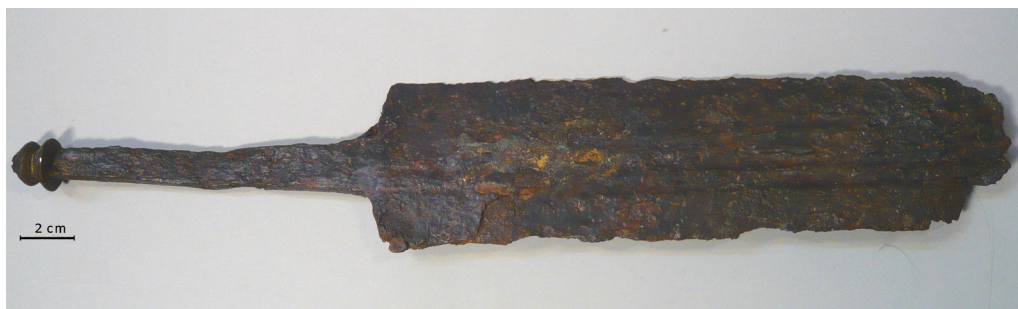
Figure 1

Image of the Roman sword showing the remaining corrosion patina after cleaning.

The examined object is a Roman sword of a type called Gladius (see Figure 1). It was found in the north-east of Germany, close to the town of Pasewalk. Several manufacturing features indicate that the sword was not manufactured in this region. It was most likely carried by Germanic warriors, who broke it and sacrificed it to the gods. The sword was highly corroded.
