Lab Report XRF 443

Analysis of a Roman sword with the M4 TORNADO

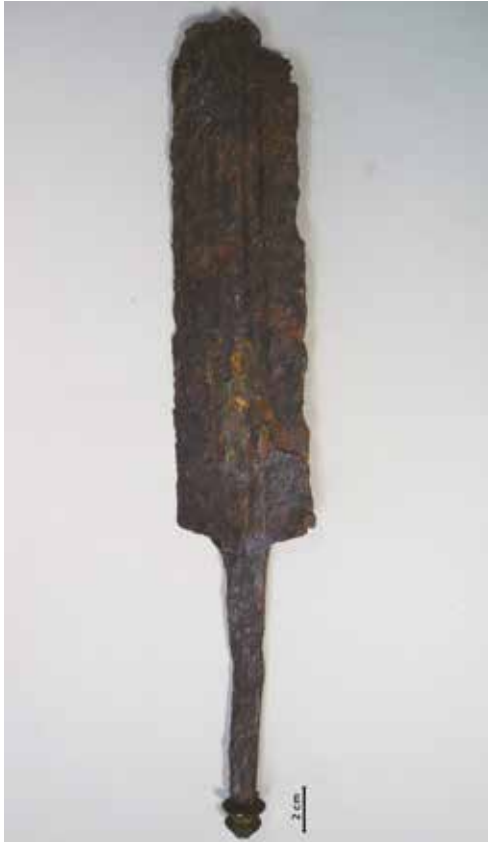
Analyzed object

Fig. 1 Image of the Roman sword showing the remaining corrosion patina after cleaning.

The examined object is a Roman sword of a type called Gladius (see Fig. 1). It was found in the north-east of Germany, close to the town of Pasewalk. Several manufacturing features indicate that the sword was not manufactured in this region. It was most likely carried by Germanic warriors,

who broke it and sacrificed it to the gods. The sword was highly corroded.

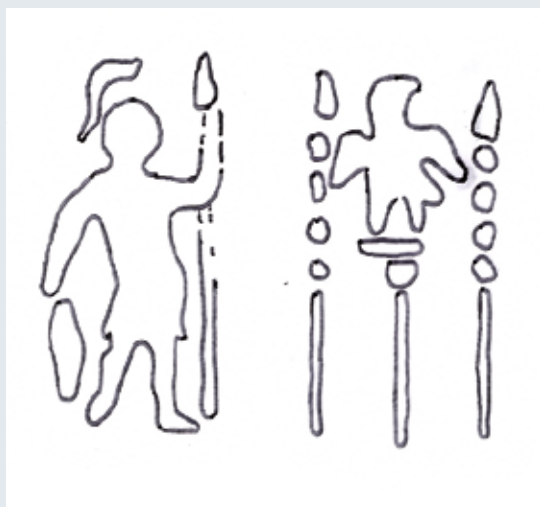
Inlaid work on the blade of the sword

Fig. 3 Drawing of the inlaid work showing the goddess Victoria and the eagle

The inlaid work shows on one side Victoria, the flying goddess of victory and the tutelary goddess of the Roman emperor. On the other side of the blade is an eagle, the symbol of the Roman legion (see Fig. 3).

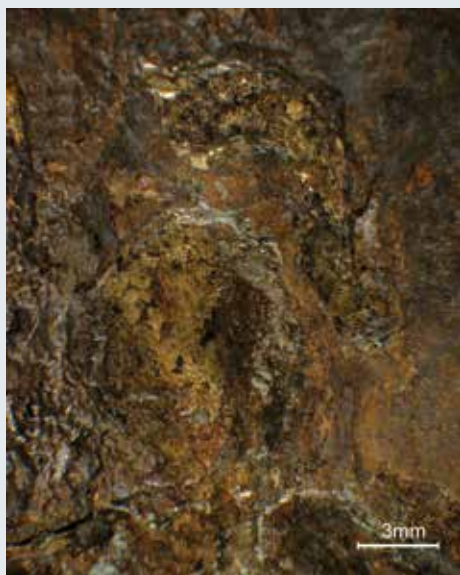
Inlaid work on the blade of the sword

Fig. 5 Picture showing the inlaid work on the blade of the sword

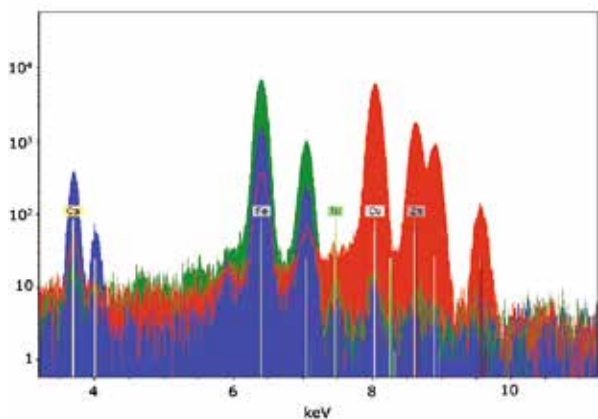
Analytical results

Fig. 7 Spectra of the measurement points (MP1: blue, MP2: red, MP3: green)

- The inlaid work (measurement point MP2) is made of brass (Cu and Zn). The single element distribution suggested that the inlaid work contains Ni. However, the red spectrum of Fig. 7 shows that there is no Ni, but the spectral background is high due to the shelf of the high Cu and Zn peaks. This has been considered for the quantification.

- The sword's blade is made of steel (measurement point MP3, green spectrum of Fig. 7). The steel contains Fe and traces of Mn and Ni. The other elements in this spectrum (Cu, Zn and Ca) result from contamination from the inlaid work and also from the environment, since the object lay on the ground for a long period of time.

- The results for the measurement point MP1 show a high content of Ca but reduced concentrations of Fe, Mn and Ni, as displayed in the blue spectrum of Fig. 7. The intensity of Cu and Zn is also higher than in MP3. This is probably due to a slightly different composition of the corrosion layer covering the metal.
