Application Note #1536

Mechanical Characterization of Corrosion-Resistant Coatings

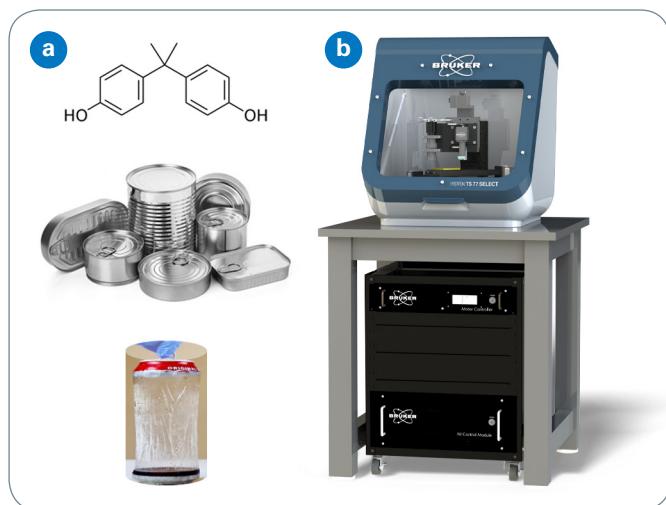
Figure 1. (a) Representative food and beverage can liner images; and (b) Bruker's Hysitron TS 77 Select benchtop indenter.

Three corrosion-resistant polymers from soft drinks of varying pH (10 x 10 mm), from different manufacturers were attached (using Loctite 420) to metal discs, while maintaining the original can curvature. The liner coatings on these samples were in contact with the highly acidic beverages for over one year. The pH values of the drinks are shown in Table 1. Surface topographical variations, as well as modulus changes, were mapped using Bruker's Hysitron TS 77 Select benchtop nanoindenter equipped with dynamic nanoindentation (Figure 1). Scratch resistance of the coatings was evaluated using Bruker's two-dimensional capacitive transducer.
