MICRO-XRF

Analysis of steel corrosion using micro-XRF

Application Note # XRF 451

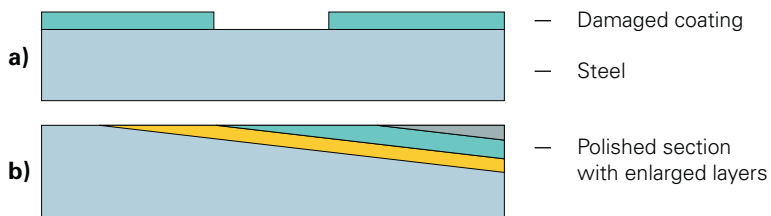
Figure 1

a): Layer structure of a steel sample with coating and damaged area,
b): structure of a prepared sample (polished section)

The samples were pieces of low-alloy steel which were treated differently. Parts were either coated with galvanic Zn layers or dip-coated in a ZnAl alloy melt at approx. 600 °C. The coating was removed at a small area of the sample. Its structure is shown in Figure 1a. Then these structures were treated with seawater, respectively with a 5 % NaCl solution at 50° C for 64 hours. For distribution analysis the samples were embedded in epoxy. Because coatings and corrosion layers are relatively thin, the samples were polished at an angle of 5.7 deg. This led to an enlargement of the layers by a factor of 10. The according structure is shown in Figure 1b. A sample prepared in this manner is shown in Figure 2. Here the corrosion is very strong due to a treatment in NaCl solution. In the center the Zn coating was removed which leads to even more noticeable corrosion. The corrosion penetrates into the steel and the corroded area seems to be very thick. Nevertheless, it has to be considered that the upper layer can be seen through the epoxy.

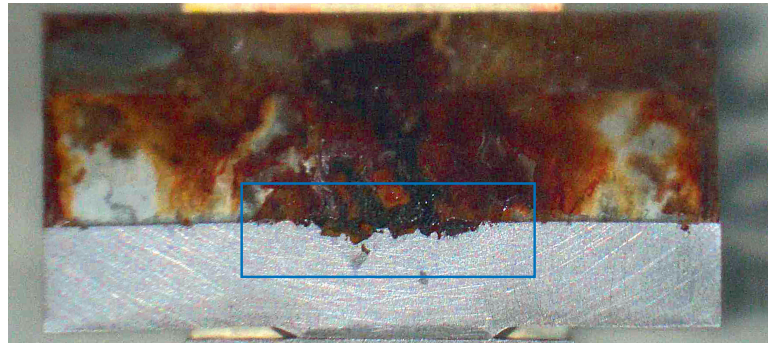
Figure 2

A sample embedded in epoxy with area marked for analysis

These conclusions are also valid in case of a treatment with the more aggressive NaCl solution. This can be seen in the distribution shown in Figure 7 of the Zn-coated sample depicted in Figure 2. There is a high Fe content in the corroded area which is diffused there by the corrosion process. Cl can be detected between Fe and the Zn coating, i.e. it is diffused in that area during the corrosion process, too. It seems that Fe has damaged the Zn coating at the edges of the damaged region because it diffuses into that area. This means the corrosion layer is very strong and the protection is not very effective.

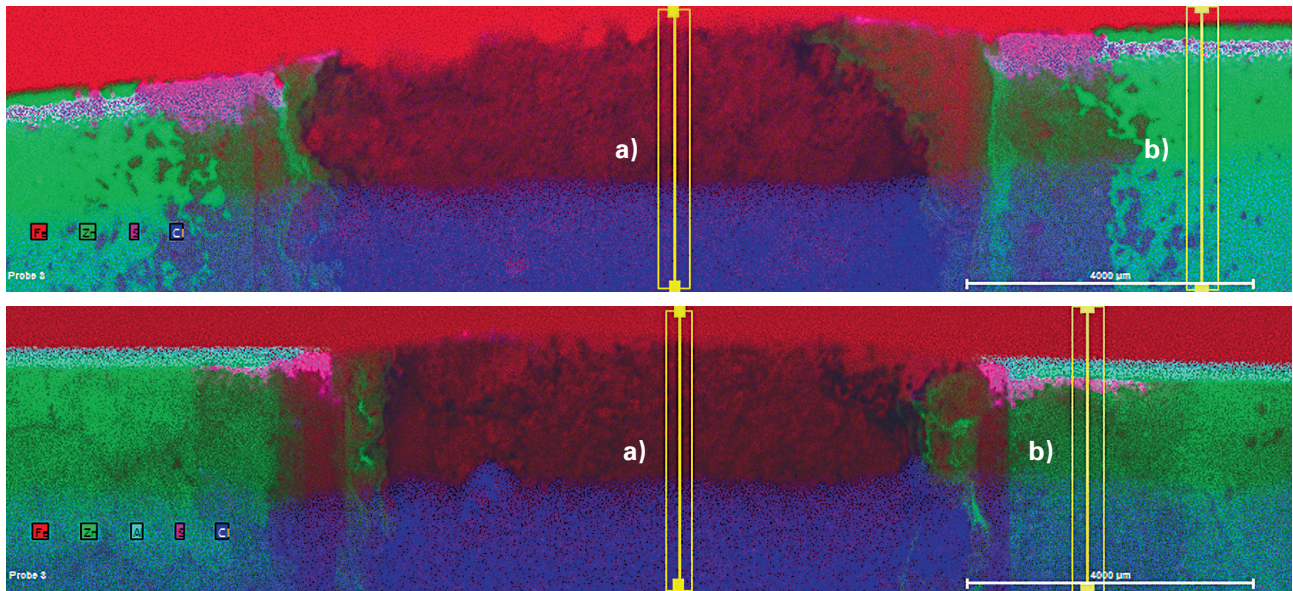
Multi-element distribution of ZnAl-coated steel after seawater treatment, with areas of line scans

from the seawater treatment. The distribution of Al in Figure 4 is bluish green. It is concentrated within the coated area between steel (Fe) and Zn coating.

Comparing the boundaries of the element distributions in Figure 3 and Figure 4 it can be concluded that conventional Zn coating is more sensitive to corrosion than ZnAl coating. It seems that Al is concentrated at the interface between steel and Zn coating.

More detailed information can be deduced from the single element distribution of line scans perpendicular to the layer system (broad yellow lines in Figures 3 and 4). These distributions can be calculated from map data because for all pixels the complete spectra are saved. In that line scans the intensities are normalized to the highest intensity of every element. Therefore they do not represent the real intensities. For a better understanding of the differences in corrosion protection the line scans were calculated for two different areas of each sample – for one with protective coating (line scans a) and for one with removed coating (line scans b). The resulting lines for the distributions of both coating types are shown in Figure 5 top to 6 bottom.

a sample with ZnAl coating after the same seawater treatment. The decrease of Fe in the coated area (Figure 6 top, line scan a in Figure 4) is very strong. Al is mainly concentrated on top of the steel and the Zn coating is almost free of Al. S again penetrates between steel and protective coating but does not reach the steel due to the Al layer. On the right side both S and Cl increase as a result of the epoxy embedding. Also in the area free from Zn (Figure 6 bottom, line scan b in Figure 4) the Fe intensity decreases significantly but the Al intensity is very low. The strong fluctuations are caused by statistics. The concentrations of Cl and Zn are also low in that area. They increase as well as S in the epoxy.

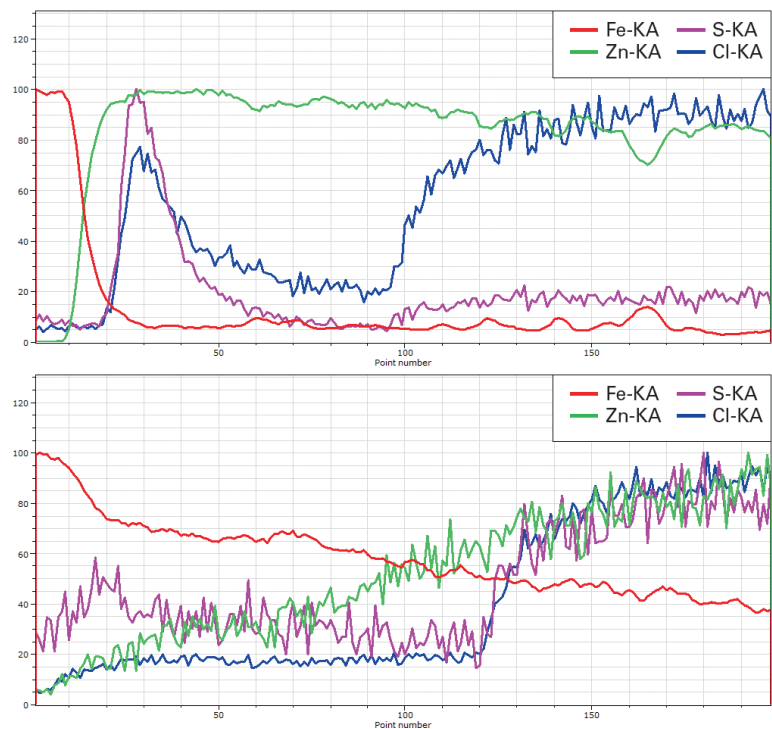
Top: Line scan (a in Figure 3) of Zn-coated material, bottom: Line scan (b in Figure 3), in the region where Zn was removed

Figure 5 top shows the linear element distribution of the line scan a in Figure 3 perpendicular through the layer system in the Zn-coated area. At the top of the sample, respectively on the left side of the line scan, the Fe intensity (red) is high and represents the steel. It decreases significantly while the Zn intensity of the coating (green) increases. In between there are higher intensities of S (purple) and Cl (blue) which are affected by corrosion penetration. Cl increases slightly on the right side due to its content in the epoxy. The sharp boundary between Fe and Zn shows that the corrosion protection works well.

Figure 5 bottom shows the element distribution of the line scan b in Figure 3 in the area of the same sample, where Zn was removed. Here the distribution of Fe decreases slowly because it is diffused into the corroded region by the corrosion process. Zn increases slowly due to the same process. Both Cl and S increase again on the right side of the line scan – a result of their content in the epoxy. In general it can be seen that the corrosion protection is less effective because Fe is diffused in the corrosion area.

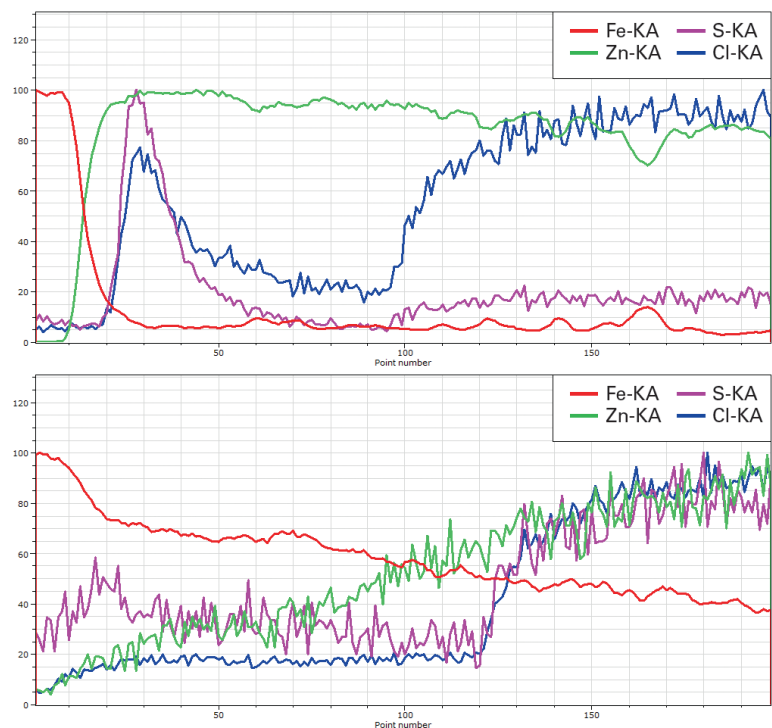
Top: Line scan (a in Figure 4) of ZnAl-coated material, bottom: Line scan (b in Figure 4), in the region where ZnAl was removed

The element distributions in Figure 6 top and Figure 6 bottom show the distributions of
