Application Note AN M112

Failure analysis of packaging materials

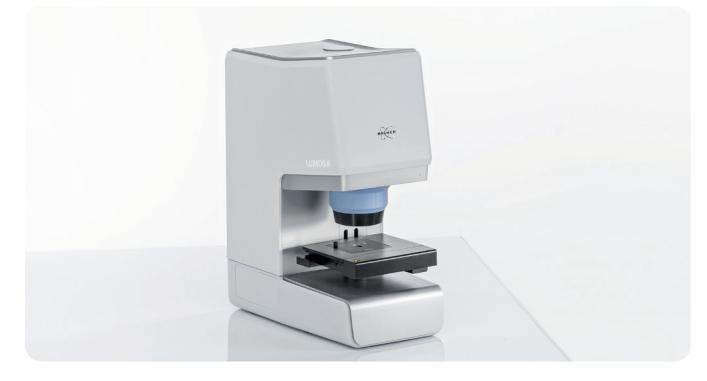
Figure 1: LUMOS II stand-alone FT-IR microscope.

The LUMOS II FT-IR microscope (figure 1) is an all in one solution with an integrated spectrometer, a high degree of motorization and a dedicated user-interface. Its 8x objective

provides the measurement modes ATR, transmission and reflection with high quality visual inspection capabilities. The innovative motorized **A**ttenuated **T**otal **R**eflectance (ATR) crystal allows performing the complete measurement procedure fully automated including background and sample measurements. Due to the high refractive index of the ATR crystal material (Germanium) even very dark materials can be analyzed. A high working distance and the unobstructed access to the sample stage facilitate an easy positioning of the sample. The large field of view of 1.5x1.2mm and the high depth of focus make sample inspection very comfortable. In combination with a motorized stage, fully automated mapping measurement can be performed.

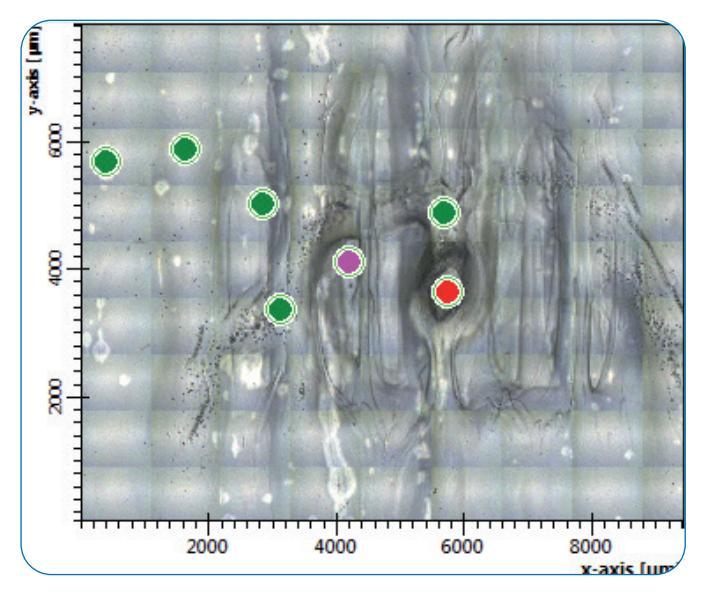
Figure 2 a: Visual microscopic image of foil with defects. Measurement positions are indicated as circles.

A transparent packaging foil with a defective area was analyzed in this example. Several measurement positions were set on the defect but also on the intact foil. The measurements were performed fully automated using the ATR-mode with an acquisition time of 20 seconds/spectrum and at spectral resolution of 4 cm⁻¹. The polymer used as foil material could be identified as a polyvinylidene chloride – acrylate copolymer by spectrum search with the comprehensive ATR-COMPLETE library (figure 2).

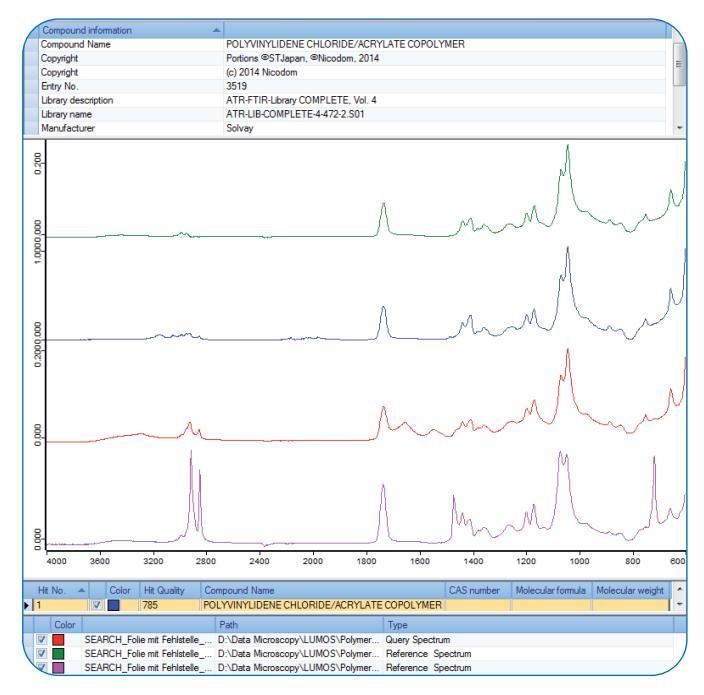
Figure 2 b: Identification of the foil spectrum (green) by spectrum search as polyvinylidene chloride – acrylate copolymer (blue spectrum). The spectra measured on the defects (red and pink) clearly show additional bands.

The spectra measured on the defective area show the spectral signature of the basic foil material but also additional bands. The library search functionality in OPUS provides powerful tools to determine the components that contribute to such mixed spectra:

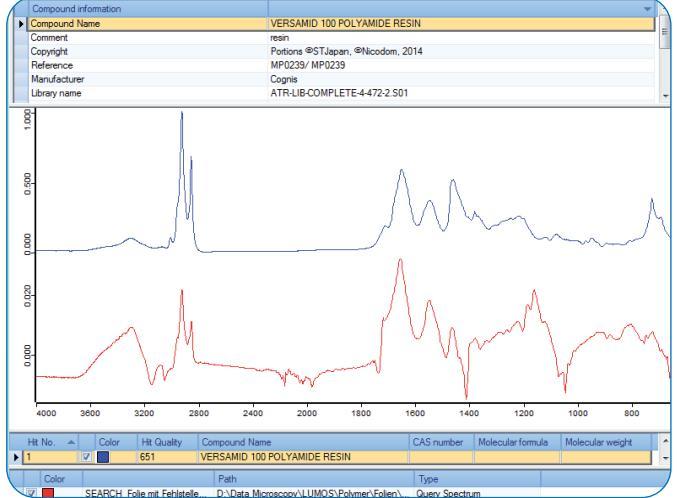
Figure 3 a: Identification of the additional component in the spectrum of the defect (red) by search of the difference spectrum between the query spectrum and the library spectrum of the basic foil material.

• If the result of a spectrum search explains some but not all of the bands of the query spectrum an automatic subtraction of the library spectrum and the search of the residual spectrum can be performed with a single mouse click. In case of the spectrum measured in the center of the black spot on the foil (red) this function provides the clear result that the additional component is a polyamide resin (figure 3 a).

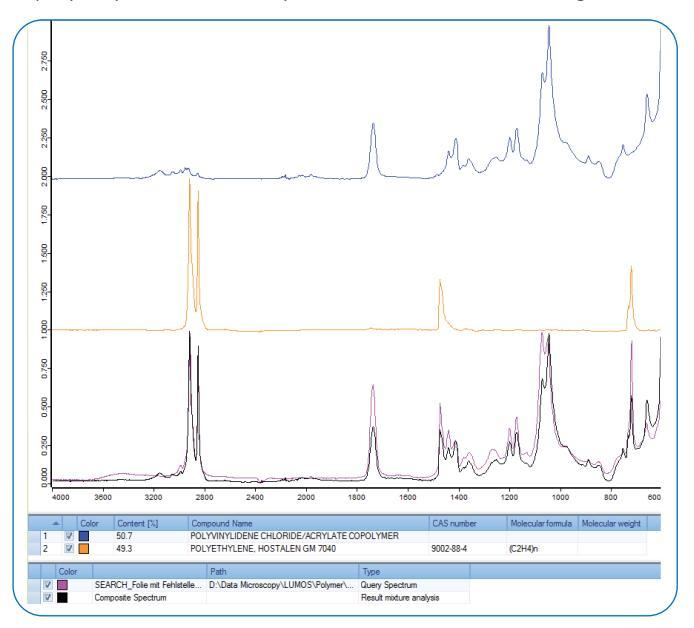
Figure 3 b: Result of the mixture analysis of the second spectrum measured on the defect (pink). Apart from the basic foil material (blue spectrum, polyvinylidene chloride – acrylate copolymer) polyethylene is detected (orange spectrum). The combined spectrum (black) of the two determined components is overlaid with the sample spectrum.

• The OPUS mixture analysis finds the best combination of library spectra to match the bands of the sample spectrum. For the second spectrum measured on the defect (pink) the mixture analysis determines the presence of a polyethylene additionally to the basic foil material (figure 3 b).

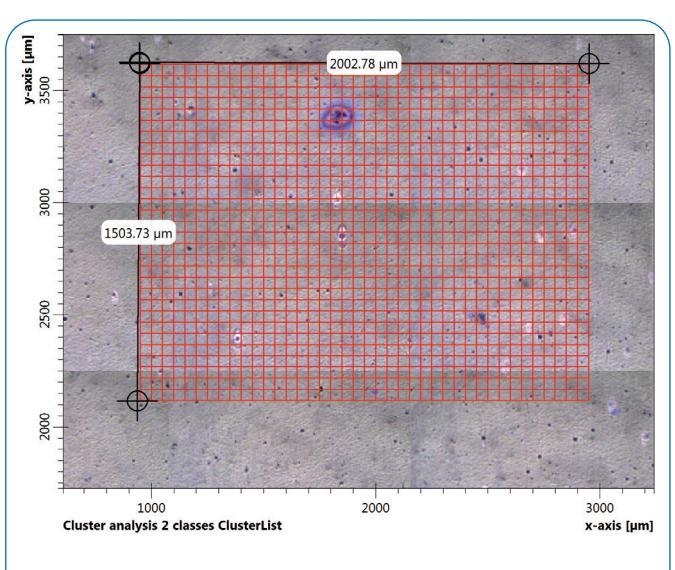
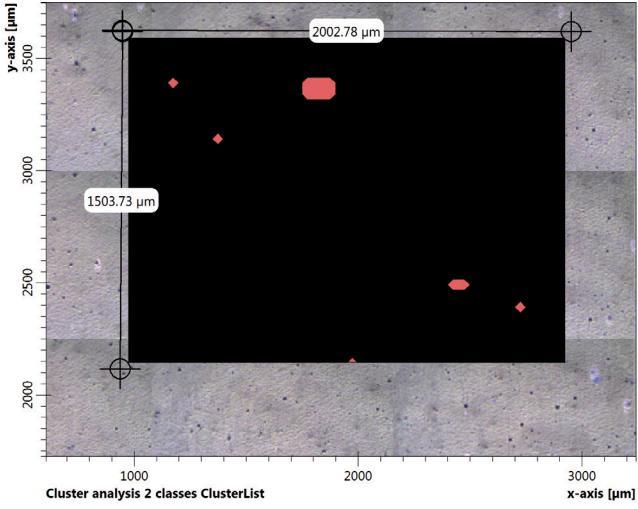
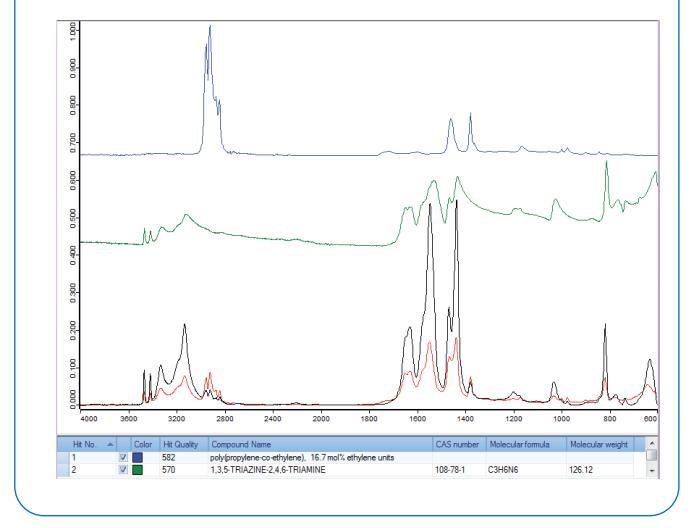
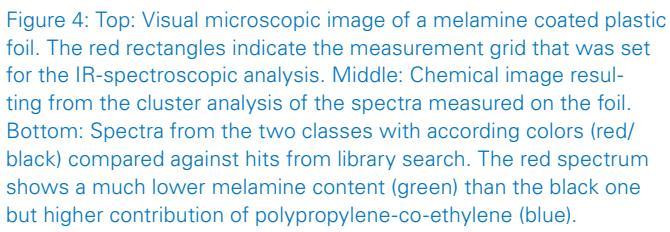
The chemical image resulting from the cluster analysis is shown in figure 4. It is obvious that the dark spots in the visual image also show a spectral deviation as they are assigned to another class (colored in red) than the matrix (colored in black).

The comparison of spectra from the "red class" against those of the "black class" reveals a lower spectral intensity of bands which belong to the melamine coating (figure 4 below). Additionally the library search clearly identifies a higher contribution of polypropylene-co-ethylene which is likely to originate from the substrate beneath the melamine coating.

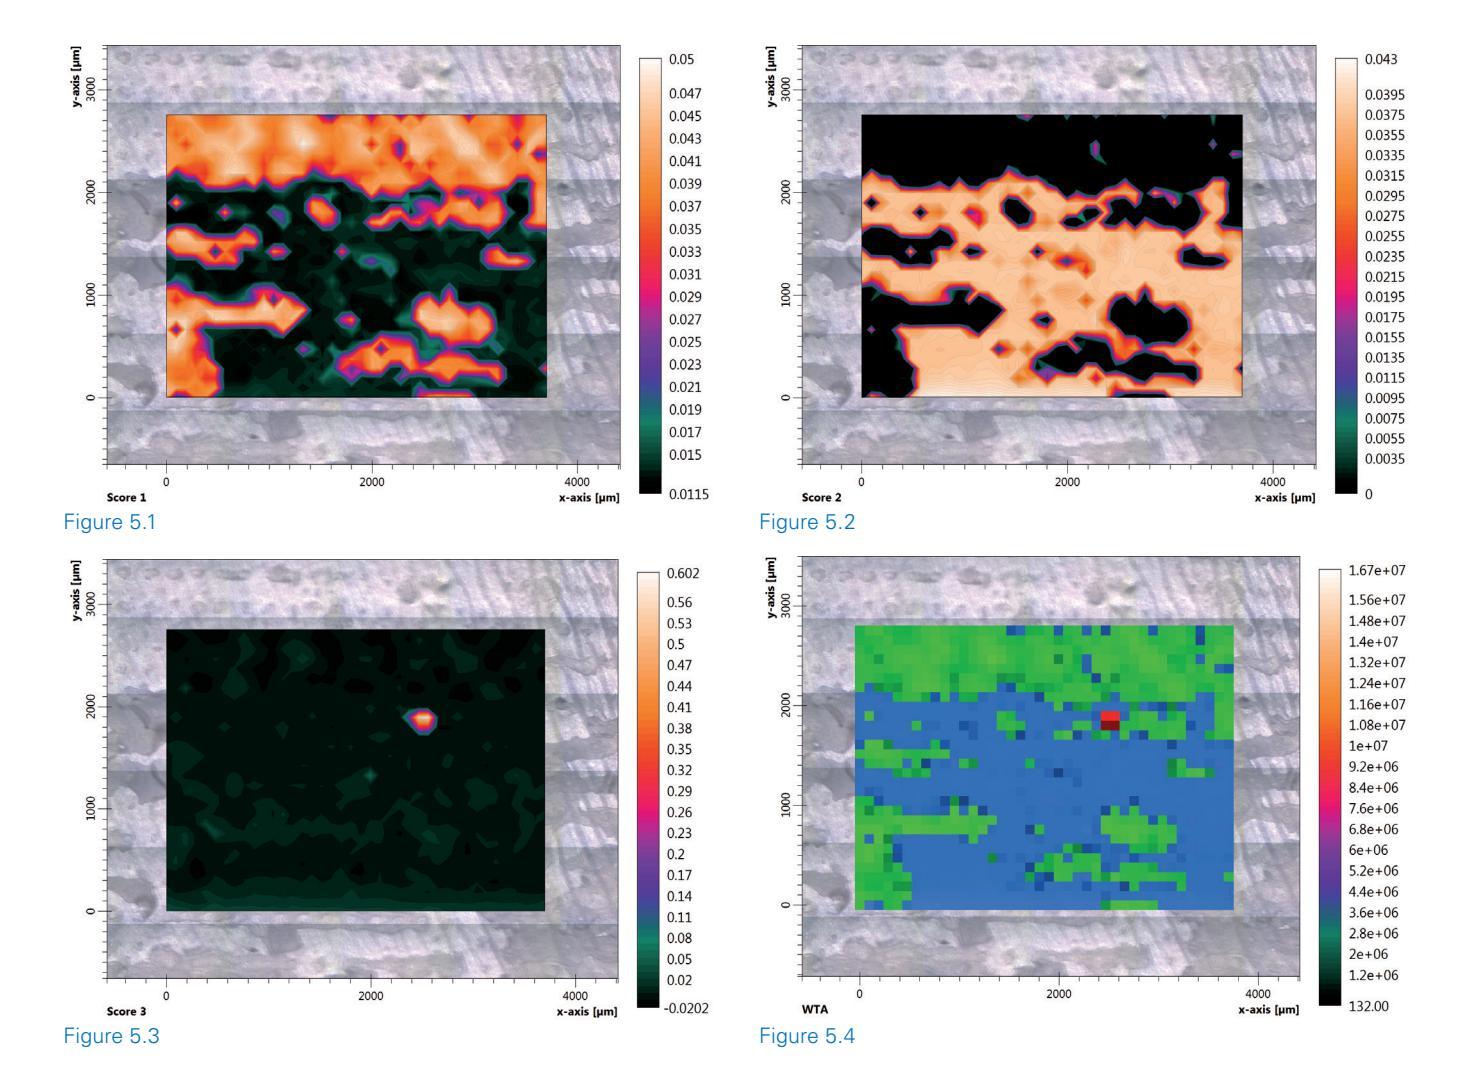
Figure 5.1 - 5.4: Chemical images of the cold seal area of a packaging foil on top of the visual image. Distribution of the cold seal (5.1), the acrylic layer (5.2) and of the defect (5.3). The image number 5.4 shows the information of the individual chemical images combined in one single WTA-image (green = acrylic layer, blue = cold seal and red = defect).

In this example the first two factors of the PCA represent the expected sample materials: The acrylic layer and the cold seal. The distribution of these two components is visualized in the chemical images 5.1 and 5.2 that result from the according score plots. Though, the score plot of factor 3 reveals a third component which is present only in a very limited region of the sample (figure 5.3).

With the aid of a so called "Winner Takes it All" (WTA) algorithm one plot can combine the information of different chemical images in one image. The WTA-algorithm assigns to each individual pixel the color of the dominating component thus allowing to visualize more than one component in one image. The image on the lower right (figure 5.4) shows the cold seal in green, the acrylic layer in blue and the defect in red. The according spectra of the three components are shown in figure 6.

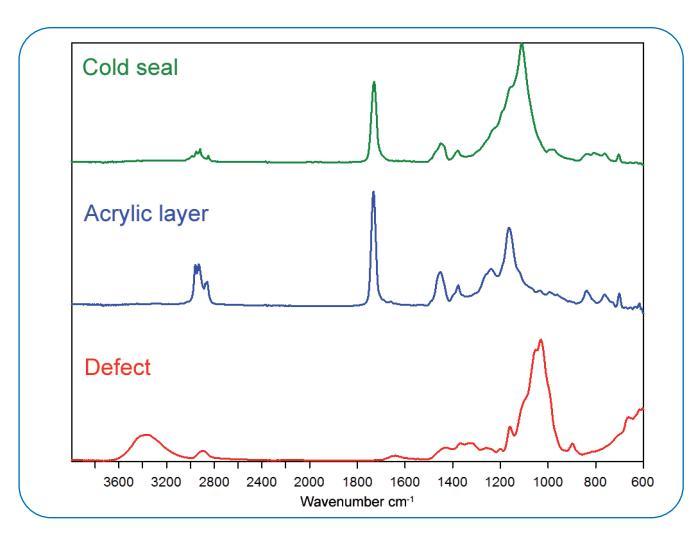
Figure 6: Typical spectra of the different components found in the cold seal area.

Identification of the components was performed by library search. As expected the coating spectrum was identified as an acrylic dispersion in dried form (trade name "Neocryl"). Also, the cold seal consists of a acrylic based polymer but additionally includes silicate as filler. The spectra measured on the defect are typical for viscose.
