Application Note AN M106

## Analysis of a CMOS Chip Circuit Board using the stand-alone FTIR Microscope LUMOS II

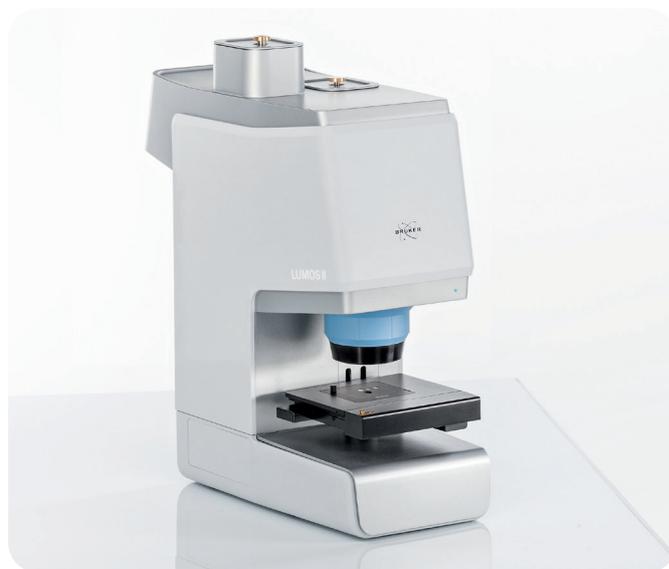
Figure 1: Stand-alone FTIR microscope LUMOS II.

complex to use and require a high level of skill. With the FTIR microscope LUMOS II (see figure 1) Bruker offers a space saving, fully automated stand-alone solution that is very easy to use.

The LUMOS II is an all in one solution with an integrated spectrometer, a high degree of motorization and a dedicated user-interface. Its 8x objective provides the measurement modes ATR, transmission and reflection and high quality visual inspection capabilities. The innovative motorized Attenuated Total Reflectance (ATR) crystal allows performing the complete measurement procedure fully automated including background and sample measurements. A high working distance and the unobstructed access for the sample stage facilitate an easy positioning of the sample. The large field of view of 1.5 x 1.2mm and the high depth of focus make sample inspection very comfortable. In combination with a motorized stage, fully automated mappings can be performed.

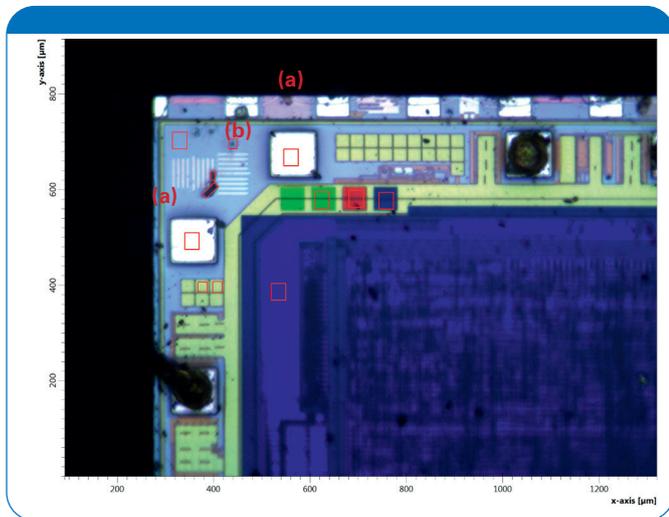
Figure 4: Corner of the CMOS imaging-chip with the measurement positions indicated as red frames.

Figure 4 shows the corner of the chip with rather complex structures including wire contacts from which two are unused. An analysis of altogether twelve measurement points shows that most of the spectra are similar to the green spectrum shown in figure 5. This spectrum is almost equal to the one already measured on the clean Bayer-matrix. Therefore we can conclude that a transparent protective polymer cover was applied on the whole chip since all the optically different positions have a similar spectrum. There are only two exceptions, the first ones are the two rectangular contact areas (a) both showing no absorptions
